**DRAFT ENVIRONMENTAL ASSESSMENT (EA)
FOR
REPLACEMENT OF AIRFIELD DRAINAGE SYSTEM AND CIRCUIT 1**

**Department of the Air Force
82 CES/CEIV**

October 2016

Replace Airfield Drainage System and Circuit 1

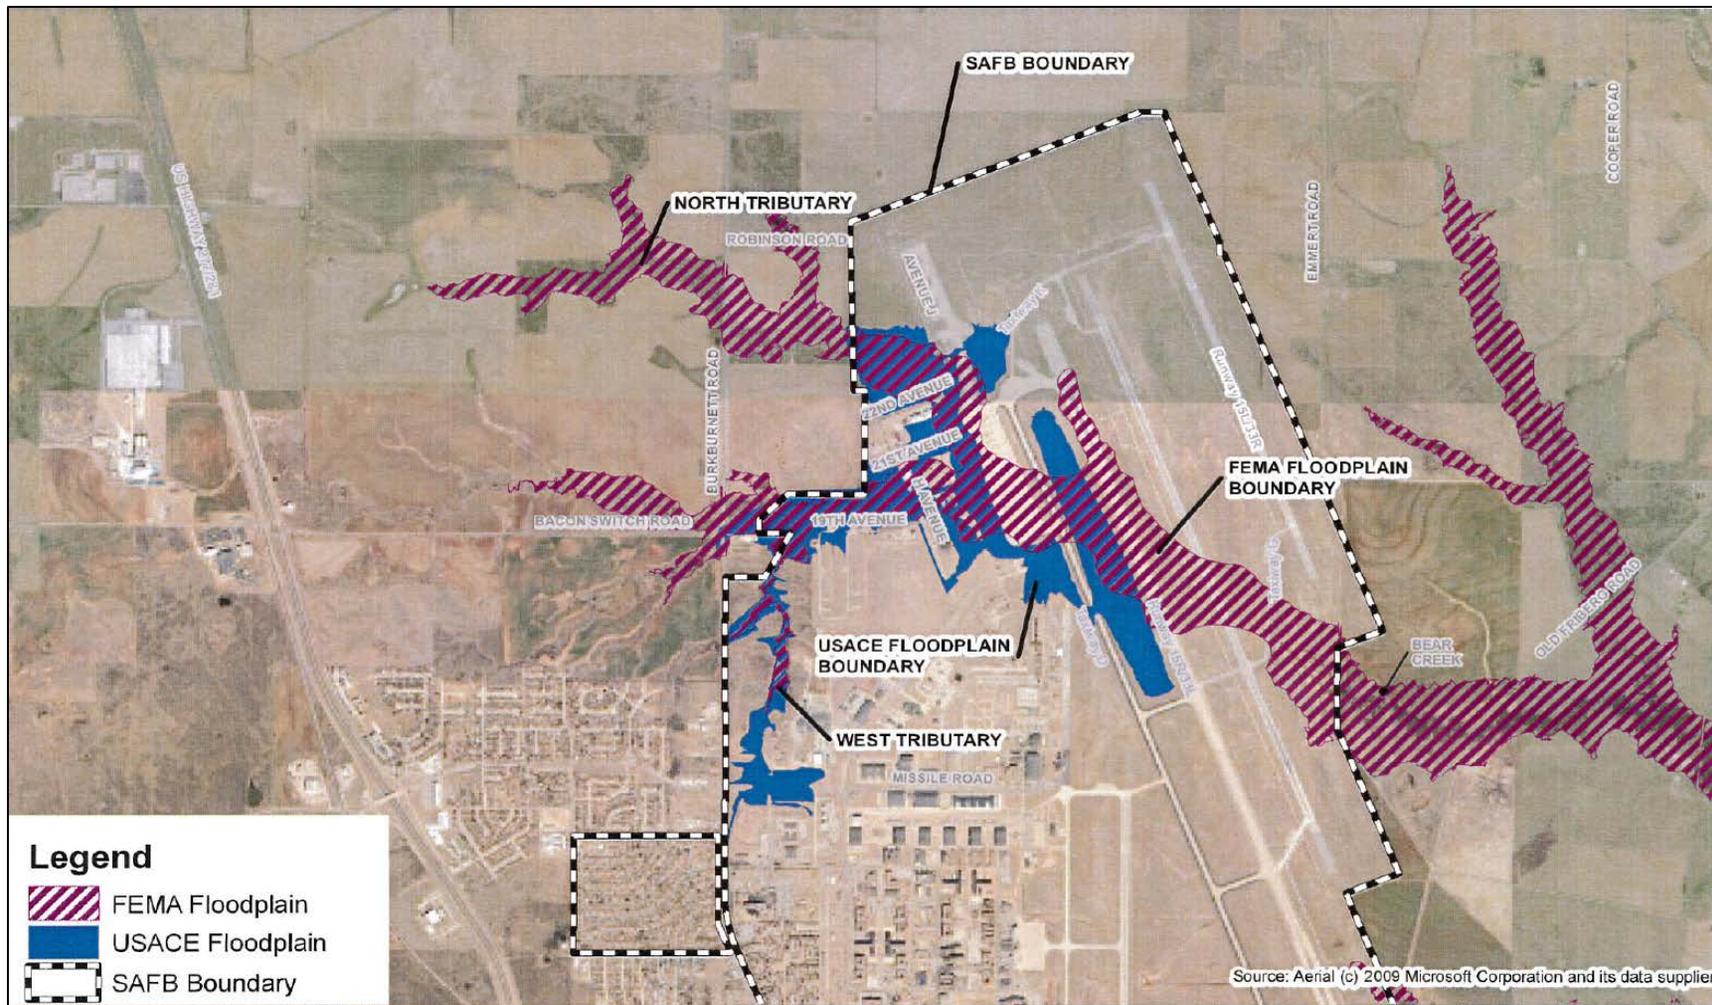
Map 4 Floodplain Boundary Map

The proposed project is located with the Federal Emergency Management Agency (FEMA) designated 100-year floodplain. Coordination with the local Floodplain Administrator would not be required as a result of this project due to the following: drainage repairs and utility work will take place in existing areas where utilities and drainage pipes were previously installed. No change to the Floodplain, such as an increase base flood elevation to a level that would violate applicable floodplain regulations and/or ordinances, is anticipated to occur from either the Preferred Alternative or the No-Action Alternative as discussed in this EA. Below is the Boundary Floodplain Map of Sheppard AFB (map 4).

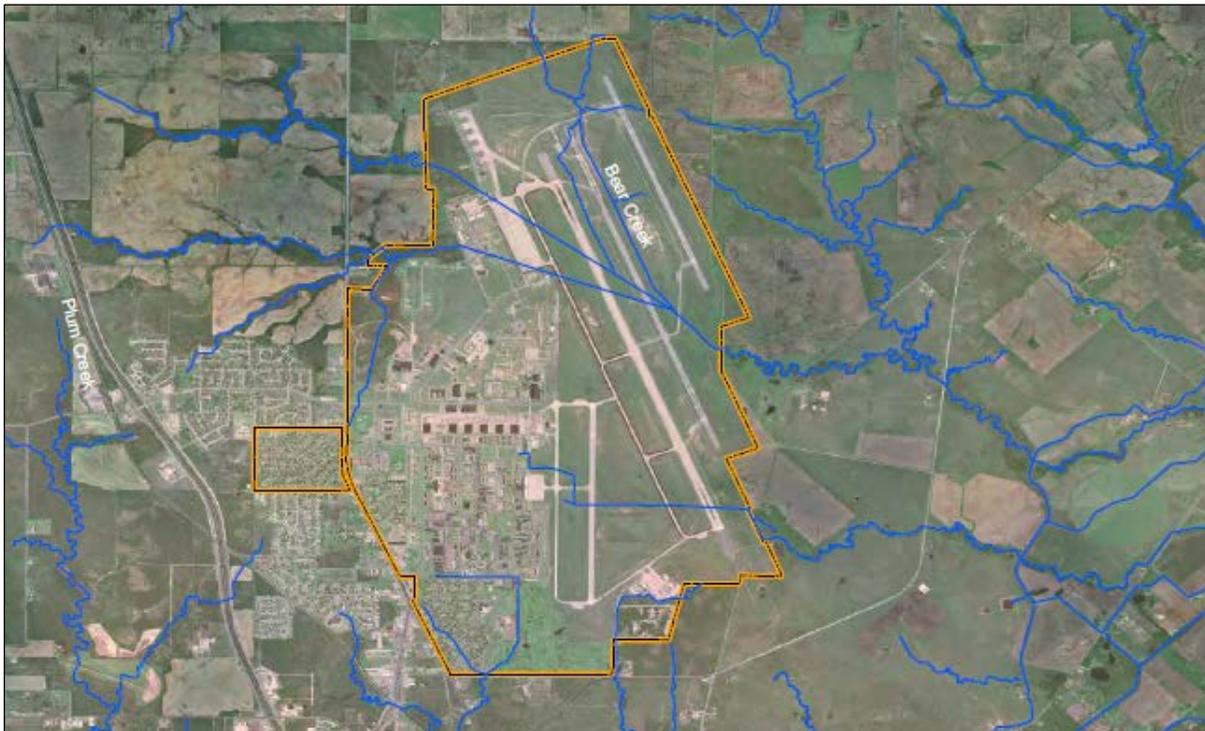
Map 5-Wetland Delineation Map

Using data from the 2014 USACOE wetland studies, there are no designated wetland areas within the project site. There would be no impact to wetlands from either the Proposed Action or No-Action Alternative.

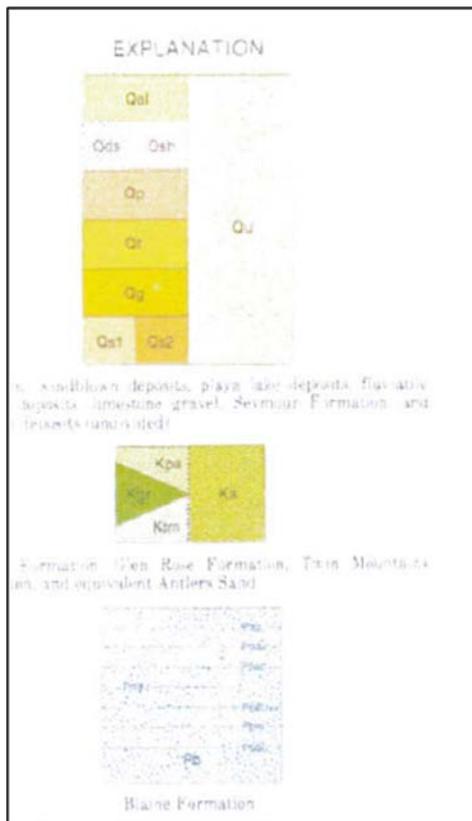
Map 6 Geology of Sheppard AFB

The majority of the strata found in Sheppard AFB are Carboniferous and Permian in age and have an eastward slope. Exposed rocks in Wichita County, where Sheppard AFB is located, contains predominantly Permian aged rocks. The Permian strata include those formations found within the Cisco Group. The Cisco Group include red clays, shales, and sandstones. The shales are generally sandy and are comprised of ferric material. Some areas in Wichita County contain limestones at higher elevations and appear in bluff regions of the county. These limestones are thin and nodular. In the valley of the Wichita River deposits of Quaternary alluvial sands and gravels have been identified. These deposits range in thickness from 20-30 feet. The alluvial deposits are believed to be Tertiary in age (map 6).

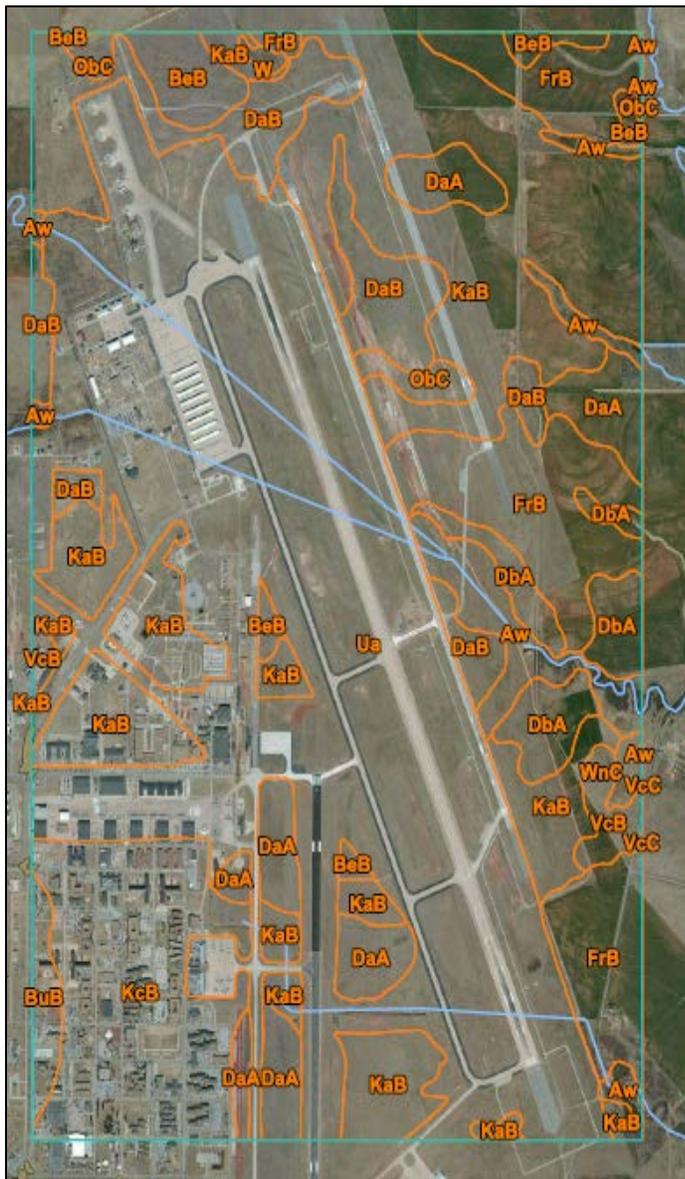
Map 7 Soil Survey Map of Sheppard AFB

Map Unit Symbol	Map Unit Name
Aw	Wheatwood and Port soils, frequently flooded
BeB	Bluegrove loam, 1 to 3 percent slopes
BuB	Bluegrove-Urban land complex, 1 to 3 percent slopes
DaA	Deandale silt loam, 0 to 1 percent slopes
DaB	Deandale silt loam, 1 to 3 percent slopes
DbA	Deandale silt loam, loamy substratum, 0 to 1 percent slopes
FrB	Frankirk loam, 1 to 3 percent slopes
KaB	Kamay silt loam, 1 to 3 percent slopes
KcB	Kamay-Urban land complex, 0 to 3 percent slopes
ObC	Jolly fine sandy loam, 1 to 5 percent slopes
Ua	Urban land
VcB	Vernon clay loam, 1 to 3 percent slopes
VcC	Vernon clay loam, 3 to 5 percent slopes
W	Water
WnC	Winters loam, 3 to 5 percent slopes

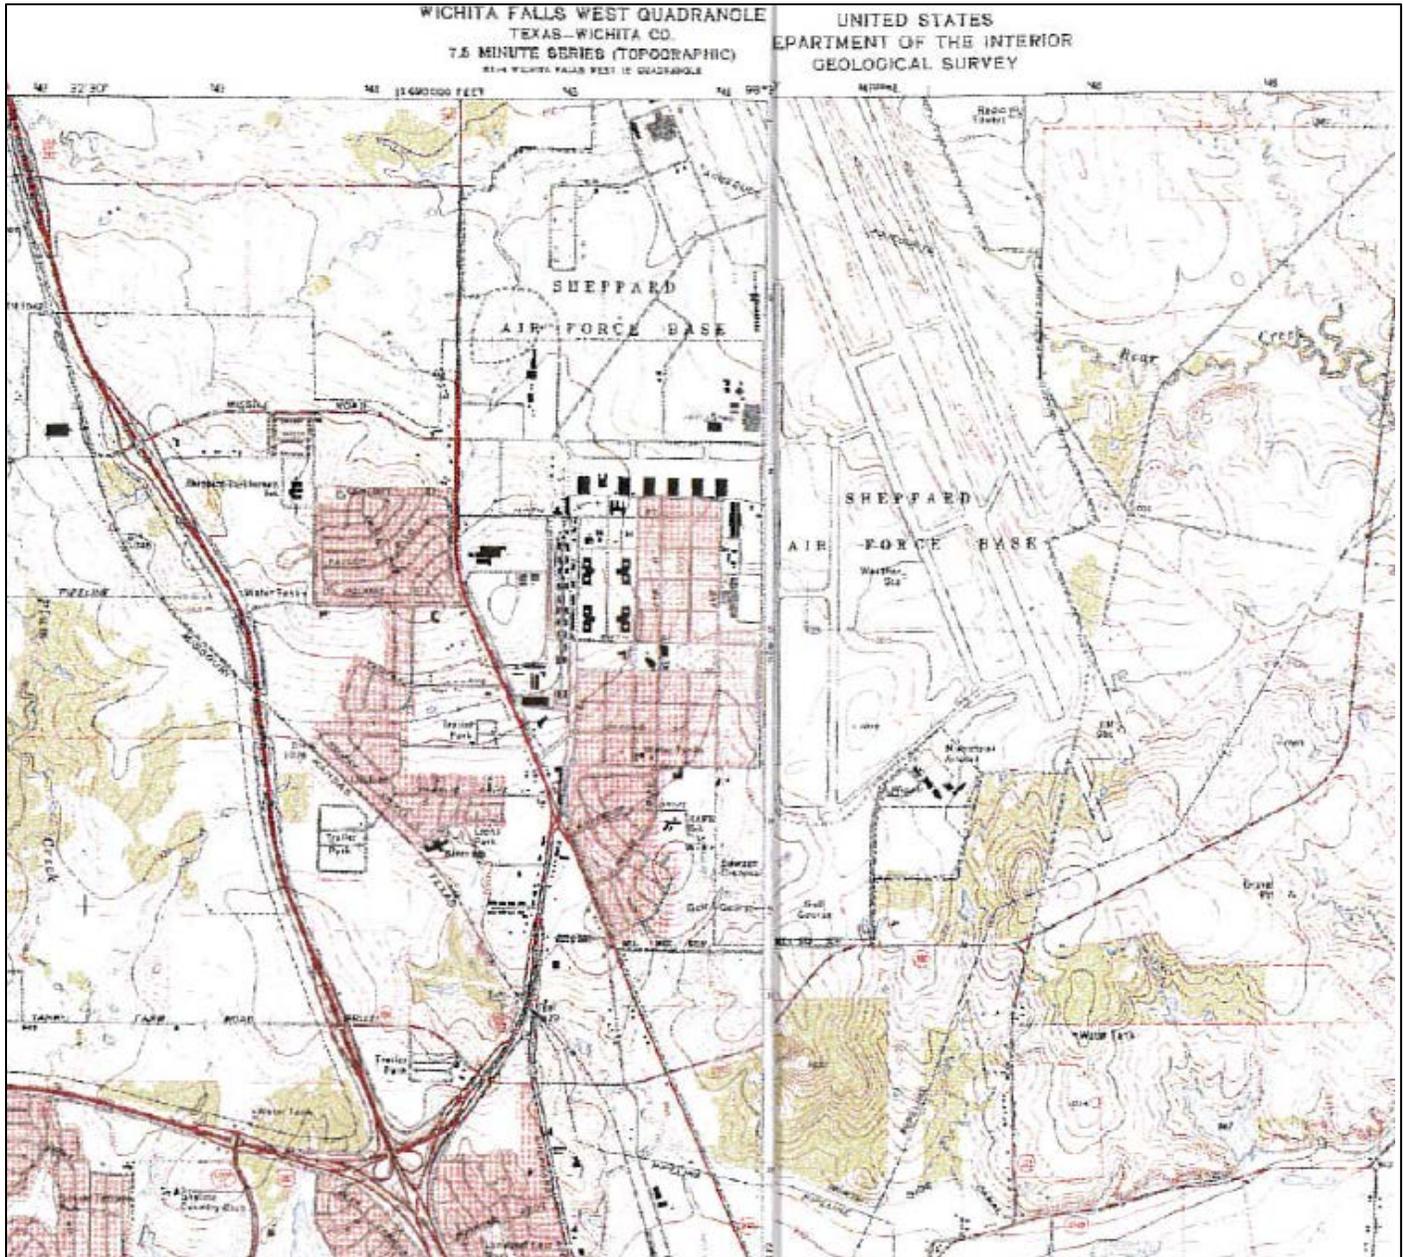
Map 8 Topographic Map of Sheppard AFB

Sheppard AFB is in a region that gently slopes eastward and is dissected by many systems of drainage. It is in an elevation of approximately 1,000-1,600 feet above sea level. Most of the land is characterized as semi-improved or improved. (Map 8)

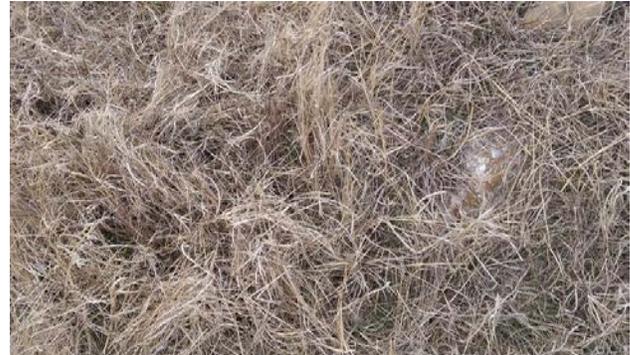
Figure 2.1 – Underdrain Outfall near Taxiway Charlie

For those runways and taxiways that have an underdrain system, field observations led to the conclusion that many of the systems do not function as intended, particularly those systems which have lateral drains that daylight to infields. The majority of the lateral drainage outfalls indicated on the plans could not be located during field observations and are believed to be buried under accumulated soil and vegetation. Those that were located were in such poor condition that they would not allow the system to drain properly (see Figure 2.1).

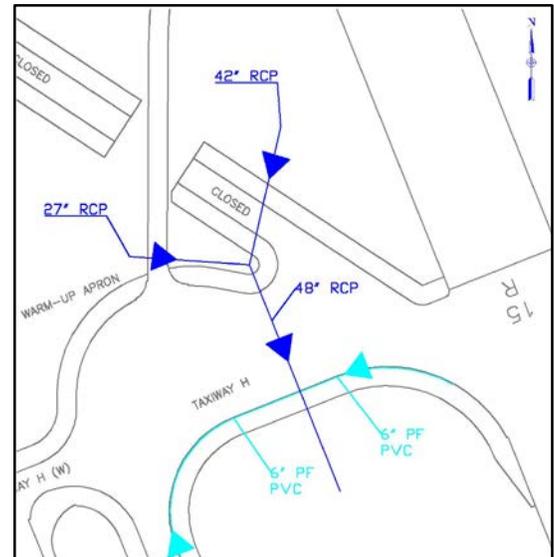
Figure 3.1 – Taxiway Hotel Drainage Structures

The four (4) soil borings taken in the vicinity of Taxiway Hotel were: Boring B1-13, B1-14, B1-15 and B1-20. These borings show the same soil types (lean or fat clay) as those found on Taxiways Kilo and Lima. Groundwater was encountered in Boring B1-14 at a depth of 11'. The concrete pavement on Taxiway Hotel is in fair condition even though there is groundwater present in the vicinity and there is an impervious soil layer beneath the subgrade. It is likely that the improved performance of this taxiway's pavement is due to a properly functioning underdrain system. As shown in Figure 3.1, the subgrade of Taxiway Hotel is drained by a 6" perforated PVC pipe that runs along the southern shoulder. Both ends of the underdrain run toward the center of the taxiway, where it connects to a 48" storm drain pipe which bisects the taxiway. The direct connection to the storm sewer system has allowed the subsurface drainage system to function properly with a minimal amount of maintenance.

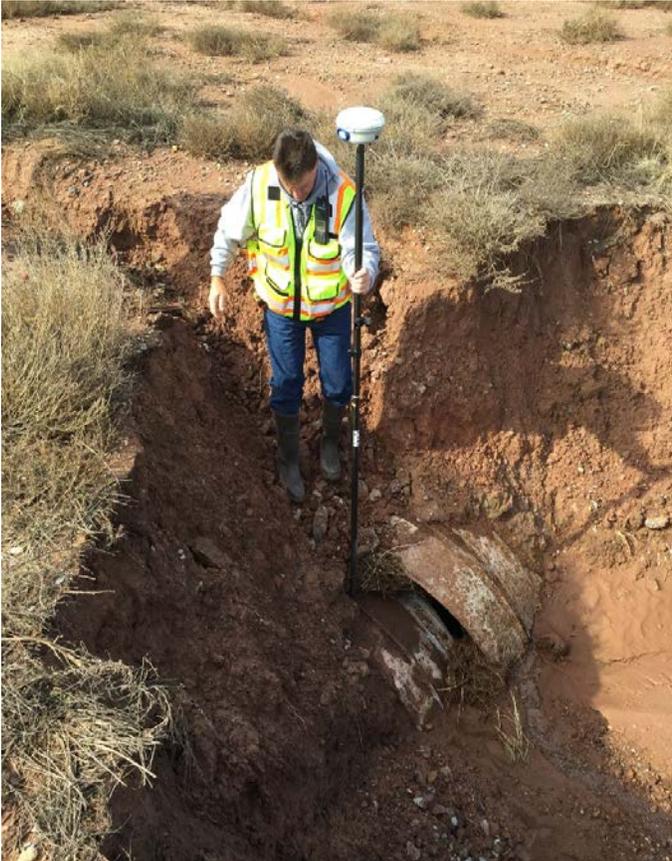
The entire Bear Creek system from the inlet north of Taxiway Lima to the outlet near the east boundary of the base was walked to document surface conditions. At the outlet, significant sediment deposits were observed in front of the two 72-inch pipes at the terminus of the Bear Creek System. In addition, during the initial site visit in September, these pipes were observed to be discharging highly sediment laden stormwater. South of Taxiway Golf, the alignment was 75-90% covered in native grass vegetation. A few small sinkholes and animal burrows were observed but the two 72-inch pipes were not exposed to the surface and there were not any inlets to check the condition of the interior of the pipes. The Phase 2 portion of the Bear Creek system that has been identified as failing was exposed at several large sinkholes (image left). There were sinkholes up to 8 feet deep where large gaps were discovered at pipe joints. The metal bands and gaskets designed to join the pipe sections together were loose and along with soil movements or wasting have created holes up to 10-inches wide at the joints. The bands and pipe have also experienced corrosion likely due to exposure to the elements and high PH conditions. The Phase 1 portion of the Bear Creek system was observed to have good vegetative cover with only a few small erosional areas.

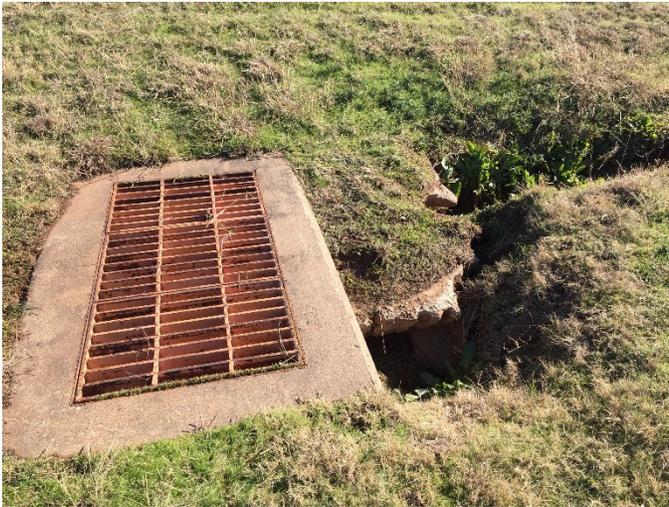
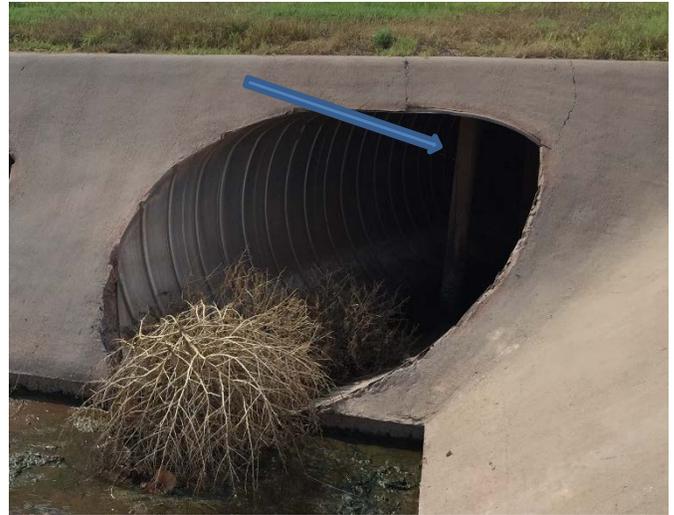
The remaining storm drain systems north of Taxiway Golf that parallel Taxiways Delta, Runway 15L and 15C were also photographed. A few areas of erosion and soil piping were observed around some of the inlets (see left photo below), but in general, the pipes and joints appear to be functioning properly. One existing corrugated metal pipe (CMP) in the infield area between Runways 15L and 15C has severe corrosion. The pipe drains a small area near the demolished taxiway that previously connected 15L and 15C. The pipe is corroded along the crown which is indicative of gaseous deposition and corrosion. The corroded pipe has caused a significant sinkhole that should be repaired when the pipe is replaced. A CMP that originates outside of the study area and terminates at the large outfall structure near the eastern boundary was also observed to be failing structurally. The pipe crown was “reinforced” with multiple 4x4 posts (see right photo below). This likely indicates that the CMP pipe either does not have enough cover per manufacturer recommendations or is not strong enough to carry live loads from vehicles that are driving over the pipe.

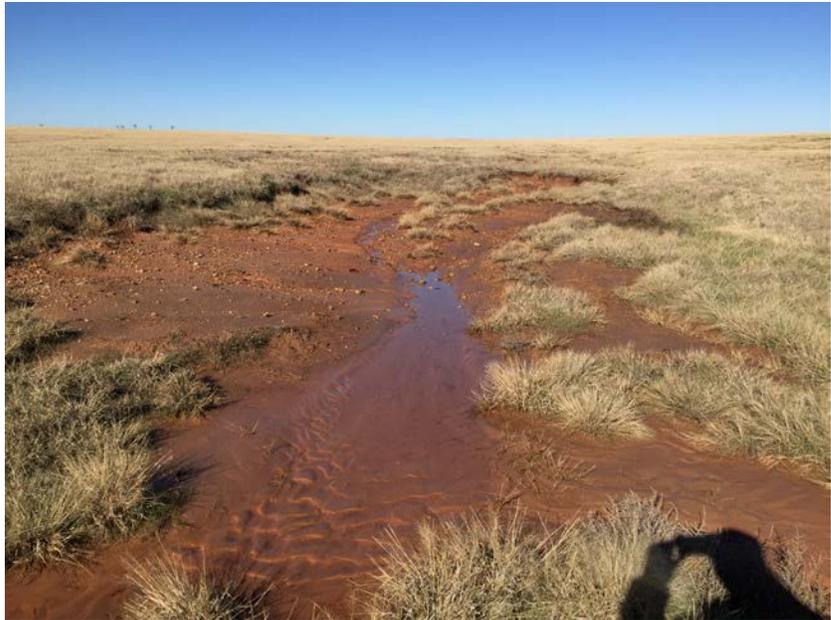
Maintenance of infield areas especially around inlets is critical to long term performance of the systems. The Taxiway Delta system and NW-SE Instrument System should be visually inspect at least once per year. Where soil erosion is occurring on the surface, filling or regrading and vegetation establishment should be performed. In areas that currently lack vegetation (see picture at right) soil samples should be sent to the Texas A&M Agrilife lab to determine if soil characteristics are inhibiting plant growth. Soils should be amended to improve and maintain plant establishment or different grass species that thrive in the soil conditions should be selected.

Where soil loss is occurring around inlets that are otherwise in good shape, a spray on lining or injected sealant should be considered for the inlet and adjacent pipe segments. This treatment can cost effectively seal up leaking storm drainage systems and prevent additional soil loss.
